Report 1866

LARC 5-7X GAS-TURBINE APPLICATION

August 1966

U. S. ARMY ENGINEER RESEARCH AND DEVELOPMENT LABORATORIES FORT BELVOIR, VIRGINIA

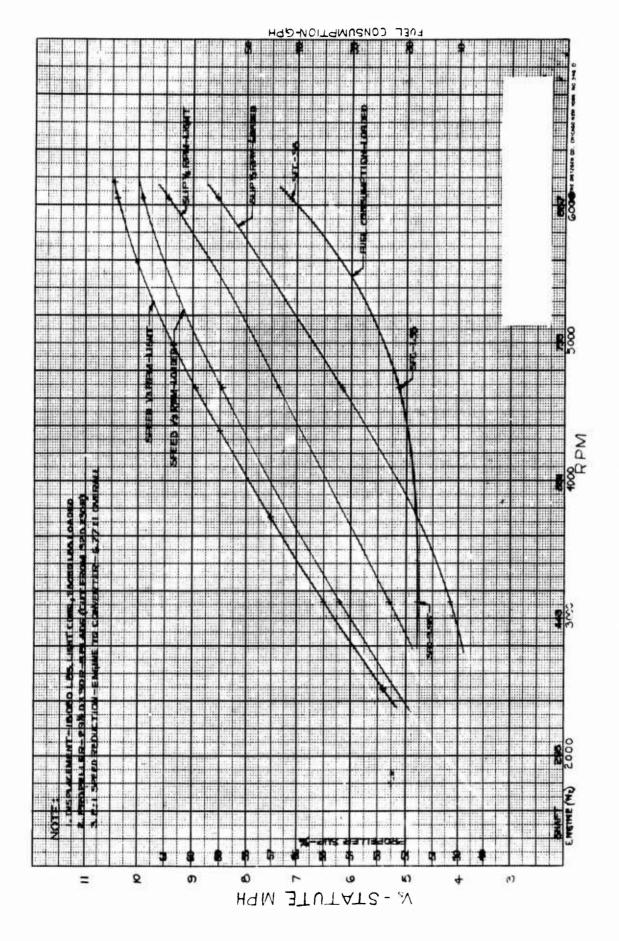
Fig. 8. LARC 5-7X water performance.

- d. <u>Vehicle Water Speed Tests</u>. In the light displacement condition, 18,050 lb, the maximum average water speed attained was 10.38 statute miles per hour at a torque converter input speed of 3,020 rpm (97 percent N2). The converter was locked up, and a propeller speed of 893 rpm resulted. In the loaded displacement condition, 28,050 lb, the maximum average water speed attained was 9.93 statute miles per hour at a propeller speed of 893 rpm. Results of these speed tests at various propeller speeds are shown in Fig. 8.

- f. <u>Fuel Consumption vs Water Speed.</u> At the maximum loaded speed attained, the turbine consumed the 5-gal-test quantity of diesel fuel in 7 min 20 sec (7:20) or 41 gal/hr. The specific fuel consumption calculates to 0.98 lb/hp/hr. Consumption at other speeds is shown in Fig. 8.

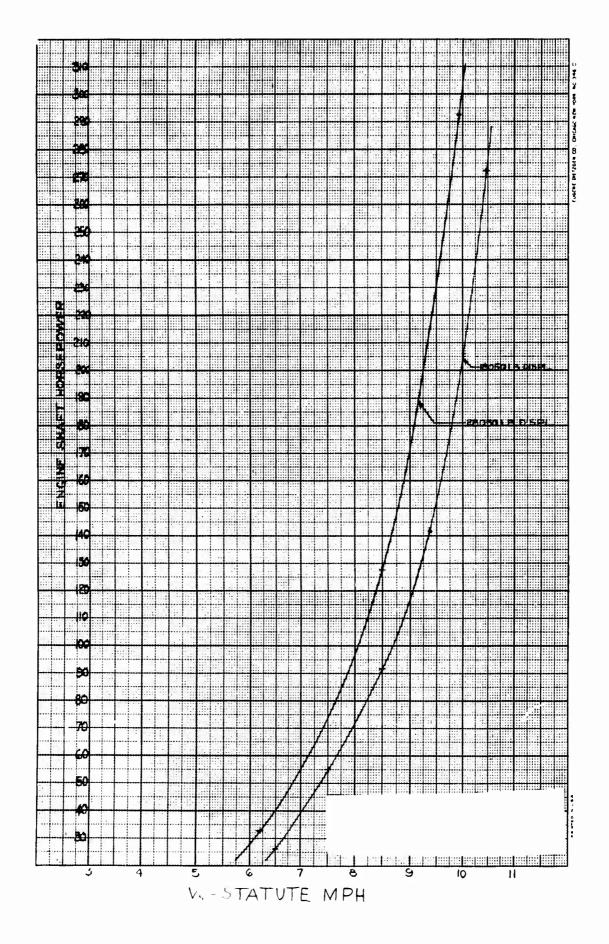
Fig. 9. LARC 5-7X marine power requirements.

- e. <u>Vehicle Power Requirement vs Water Speed</u>. In the light displacement condition, at the maximum speed attained, 10.47 mph, the turbine was producing 272 shaft horsepower as calculated from the differential pressure gage reading of 21 psi and 99 percent N<sub>2</sub>. In the loaded condition, 292 shaft horsepower was produced (23-psi differential and 97 percent N<sub>2</sub>). Power requirements for other speeds are presented in Fig. 9.

The water speed and power requirement test results can be used to evaluate power requirements for amphibian vehicles of this same configuration, the LARC 5 in particular. The LARC 5 results compared with the earlier trials show that the power train losses can be accurately pinpointed rather than estimated. Data recorded show that with no load a maximum average speed of 10.38 mph was achieved at 3,020 converter input rpm (converter locked) and that the turbine was delivering 260 hp. With a 10,000-lb load, the maximum average speed was 9.93 mph at 3,020 converter input rpm, the turbine delivering 292 hp.
